# The Use of Unmanned Aerial Vehicles for Sloped Roof Inspections – Considerations and Constraints

## Abstract

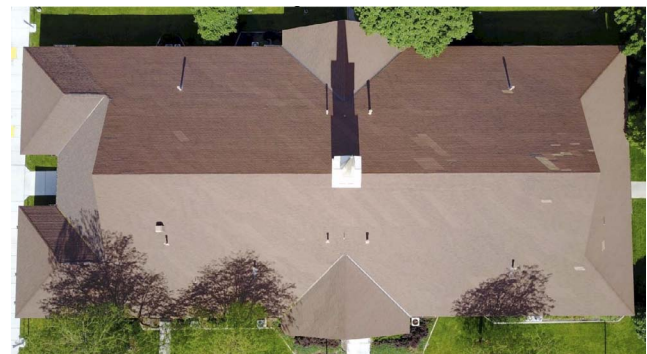
ILLUSTRATION 4.—Initial Image at 180 Feet to See Defect Zones

was found that if the entire roof was pictured at the 10-15 foot level, it was hard to keep track of which part of the roof was being shown. It is possible to get a good overview of the general condition of the roof by zooming in on the quadrant-height images, supplemented by the detail-height images. The vertical still image approach is the preferred method. It is the most efficient method to manage, and can be expanded to give more detail by dividing the roof into more sections if the quadrant height is reduced from 70 feet. Examples of image quality using this approach can be seen in Illustrations 4 and 5.

The vertical approach is to start at an elevation sufficient to see the entire roof. This was approximately 180 feet for the buildings in this study. This allows the pilot to look for areas of interest that could use closer inspection. While this can be done live while looking at the UAV control panel, it was better to download this image to a computer to inspect it. This allows the pilot to zoom in with the screen to see something more closely. This step orients the pilot to the entire roof. The next step is to move down to about 70 feet and take “quadrant” pictures, dividing the roof into 4-6 sections (for a 30,000 sqft roof). This gives the pilot a much better look at potential problem areas. It might not be necessary to download the quadrant picture to the computer to analyze it. Often, it can be seen directly on the control panel screen that there is a problem. For problems seen from the quadrant height, the pilot flies the UAV down closer to take detailed pictures of that area. These pictures might be taken from between 5-15 feet depending on the detail desired. After completing the quadrant, the pilot flies the UAV back up to 70 feet and moves to the next quadrant to repeat the process. This allows one to keep better track of which areas of the roof have the defects. If one is using a tablet computer, it is possible to draw a circle directly on the image marking areas of interest. A graphical representation of this three-stage approach can be seen in Illustration 3. The horizontal approach could be described as a shotgun approach, whereas the vertical approach is more targeted and efficient.
